Aleksander Hebda^{1*}Aleksandra Małeck², Hubert Hebda³, Jakub Zelek⁴¹ Department of Manufacturing Engineering and Materials Science, Opole University of Technology² Faculty of Biology and Environmental Protection, University of Lodz³ Mechanical Faculty, Opole University of Technology⁴ Department of Electric Power Engineering and Renewable Energy, Opole University of Technology*Corresponding author: a.hebda@po.edu.pl

Effect of tissue environment on the structure and properties of Ti-6Al-4V alloy

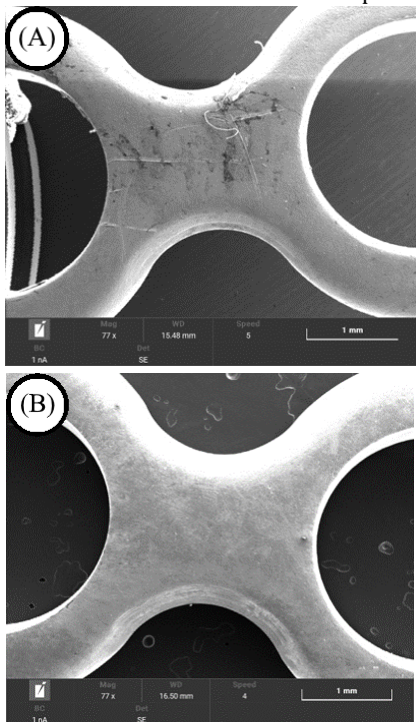
Images of the stabilization plate component were taken at 77x magnification, which allowed better observation of the details found on the surface of both versions of the plate. In the case of the image of the plate that appears in Fig. 8, there are noticeable differences between the plate after removal (A) and the new one (B). The plate after removal (A) from the tissue environment is characterized by the presence of micro-scratches, as well as some areas with applied additional foreign material not present on the unused, new plate model (B). As for the surface texture, the new and worn parts do not differ.

Figure 8. Images of the stabilizer plate: image of the used plate (A), image of the new, unused plate (B)

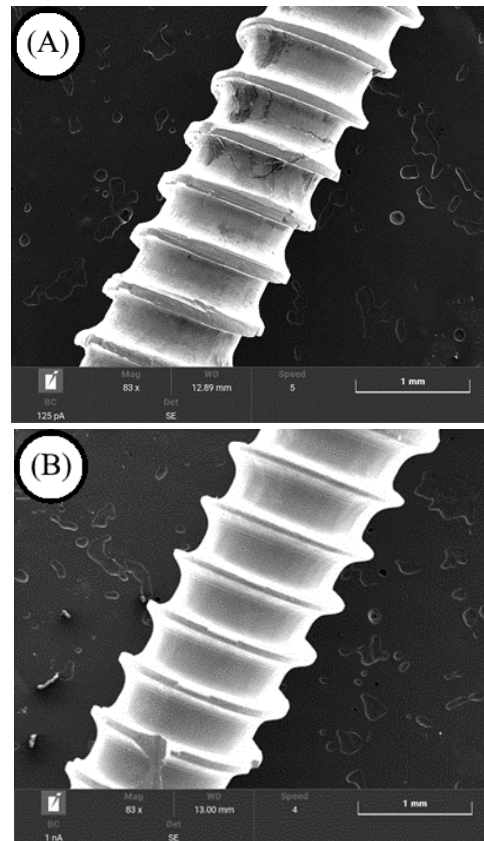
In the case of the screw element, the images for both the used version (Figure 9(A)) and the new version (Fig. 9(B)) were taken using a magnification on the order of 83x, which made it possible to see in more detail the distinguishing elements between the different versions of the screw. A uniform structure is noticeable on the unused version, which is distinguished by its uniform white contrast. It also has no deposited foreign material, the presence of which is found on the element in Fig. 9 (A). In addition, the element in Fig. 9 (A) shows a differently contrasting color, which is directed more toward gray than white as in the screw in Fig. 9 (B), which may indicate some influence of the tissue environment on the color of the implant material.

Figure 9. Images of the screw: image of the used element – the screw (A), image of the new, unused screw (B)

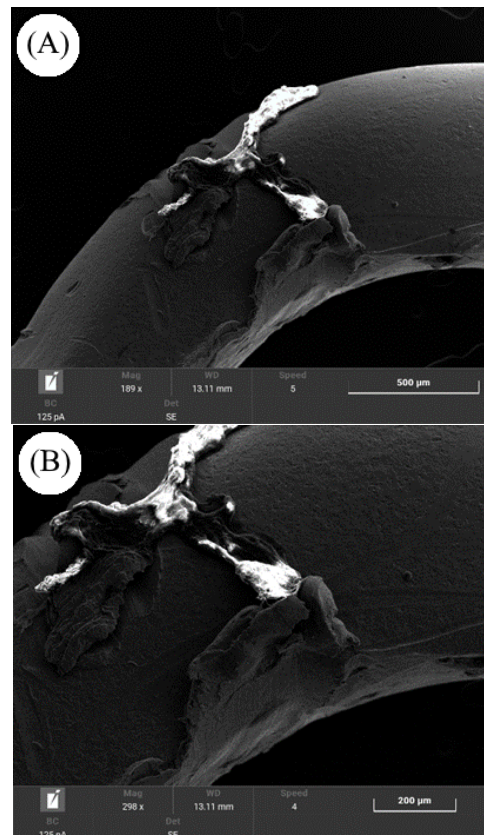
Figure 10. Images of the detail located on the stabilization plate

The Hofer INTEOS Mini Fragment, which was shown in its entirety in Fig. 6 (A), and its details shown in Fig. 8 (A), additionally displayed a spot that drew particular attention due to the presence of an unidentified object that was irregular in shape and did not look like a cavity. Its image is shown in Fig. 10. The object is characterized by a different contrast to the rest of the test plate (it contrasts brightly in the SEM image). From the images alone, it is not possible to determine the origin of the material excess. For this reason, in addition to the images showing the test material, an EDS chemical composition analysis was carried out. As a result of the analysis, graphs in the form of histograms of chemical elements detected on the surface of the material were plotted, as included in Fig. 11. The left part of the image (A) presents the results for the test material of the stabilizer plate in the worn state, while the right part of the image (B)

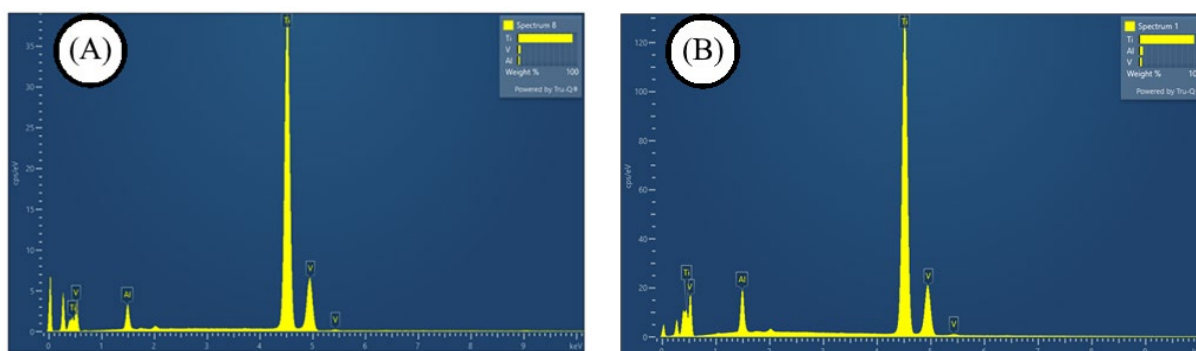
Figure 11. Chemical composition analysis in the form of a histogram of the elements of the implant material: used (A), new (B)

On the basis of the plotted histograms of the chemical composition of the test material, tables were prepared containing the percentage content of the elements included in the test alloy. Accordingly, Table 1 shows the percentage content of the chemical composition of the sample – stabilizing plate in the worn state. Table 2 shows the percentage content of the chemical composition of the sample – stabilizing plate in the delivered (unused) state.

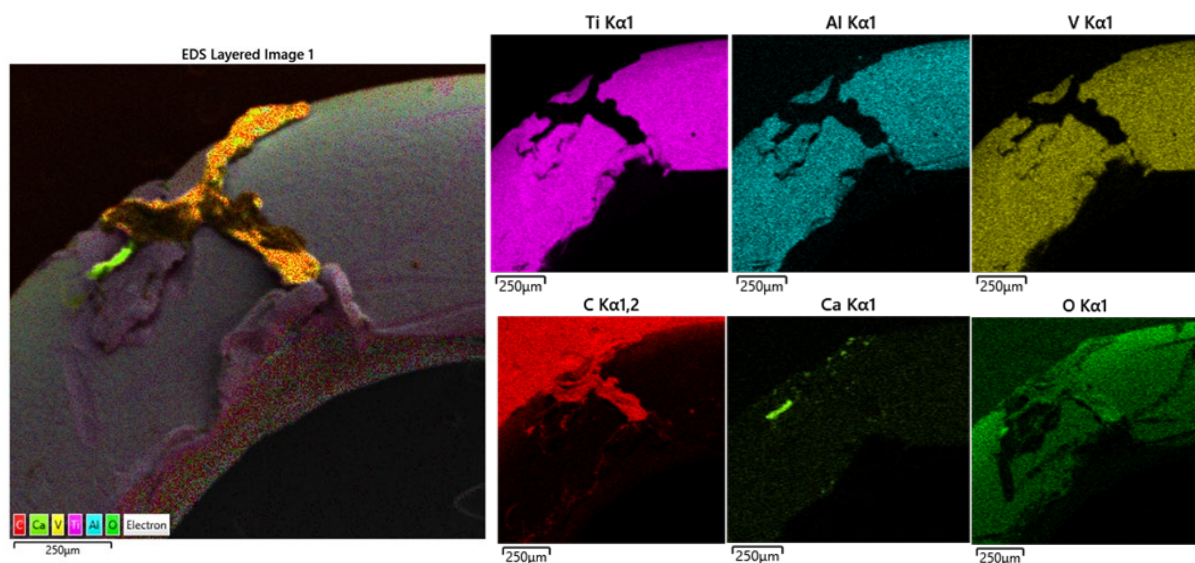
The EDS analysis of the chemical composition was used to investigate the localized foreign body component, the results of which are shown in Figure 12 in the form of spectra located on the outer layer of the material along with the distribution of the elements detected. It is noted that the foreign body in the form of a material excess adjacent to the implant material is not the source material itself (Ti-6Al-4V alloy). The element spectra shown indicate the presence of calcium (Ca), carbon (C) and oxygen (O).

Figure 12. The analysis of the chemical composition of the localized detail of the deposited foreign body on the element of the stabilizing plate and the individual spectra of elements

The presence of carbon (C), calcium (Ca), oxygen (O) on the plate taken from the tissue environment may indicate the deposition of a layer of calcite (calcium carbonate) on the surface of the alloy, which may indicate that orthopedic implants can cause various tissue reactions, including mineral deposition. The tissues around the implant may try to "integrate" the foreign material, which can lead to the deposition of minerals, including calcite. However, this process is not dangerous to the tissue environment.
