## Effect of tissue environment on the structure and properties of Ti-6Al-4V alloy

This study characterizes the material characteristics of the Hofer stabilizing plate, in the form of a used plate that resided in the tissue environment acting as a stabilizer for the spiral-fractured 3rd metacarpal bone and a new, unused plate.

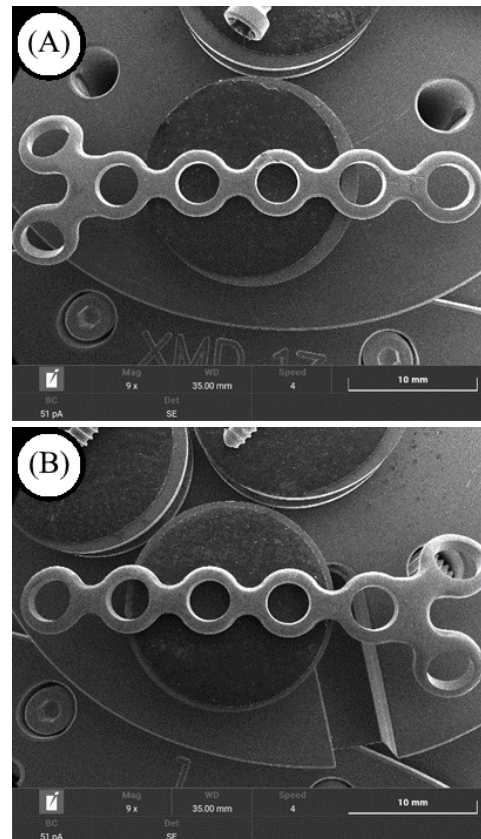
**Figure 6.** Images of the stabilizer plate: image of the worn plate (A), image of the new, unused plate (B)

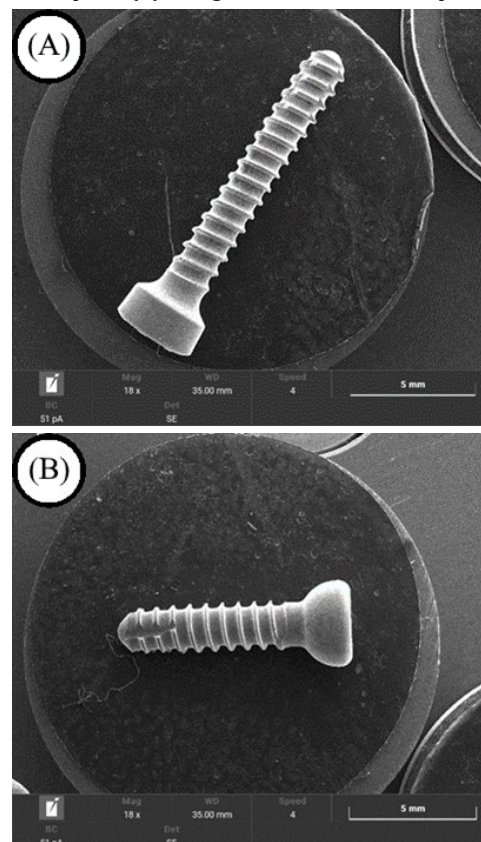
**Figure 7.** Images of the element in the form of a screw: image of the used element - the screw (A), image of an element – the new, unused screw (B)

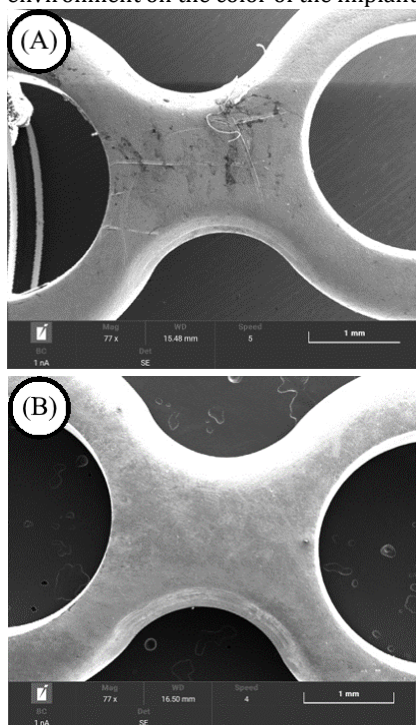
Images of the stabilization plate component were taken at 77x magnification, which allowed better observation of the details found on the surface of both versions of the plate. In the case of the image of the plate that appears in Fig. 8, there are noticeable differences between the plate after removal (A) and the new one (B). The plate after removal (A) from the tissue environment is characterized by the presence of micro-scratches, as well as some areas with applied additional foreign material not present on the unused, new plate model (B). As for the surface texture, the new and worn parts do not differ.

**Figure 8.** Images of the stabilizer plate: image of the used plate (A), image of the new, unused plate (B)

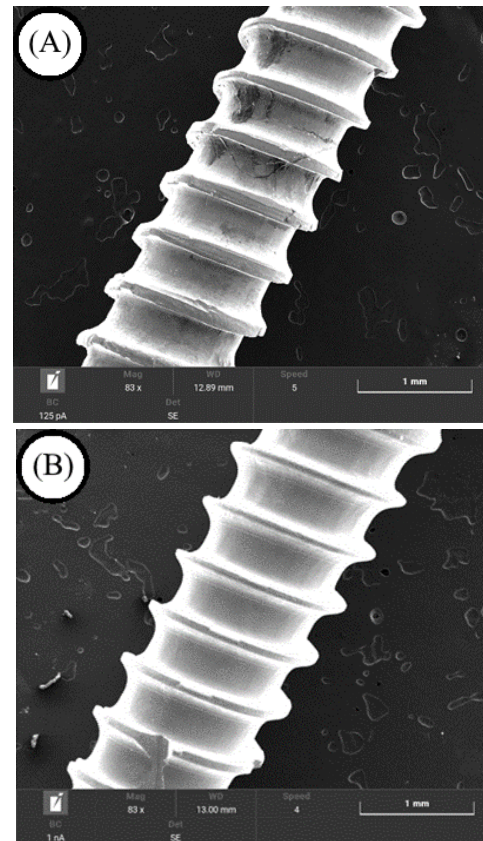
In the case of the screw element, the images for both the used version (Figure 9(A)) and the new version (Fig. 9(B)) were taken using a magnification on the order of 83x, which made it possible to see in more detail the distinguishing elements between the different versions of the screw. A uniform structure is noticeable on the unused version, which is distinguished by its uniform white contrast. It also has no deposited foreign material, the presence of which is found on the element in Fig. 9 (A). In addition, the element in Fig. 9 (A) shows a differently contrasting color, which is directed more toward gray than white as in the screw in Fig. 9 (B), which may indicate some influence of the tissue environment on the color of the implant material.

**Figure 9.** Images of the screw: image of the used element – the screw (A), image of the new, unused screw (B)

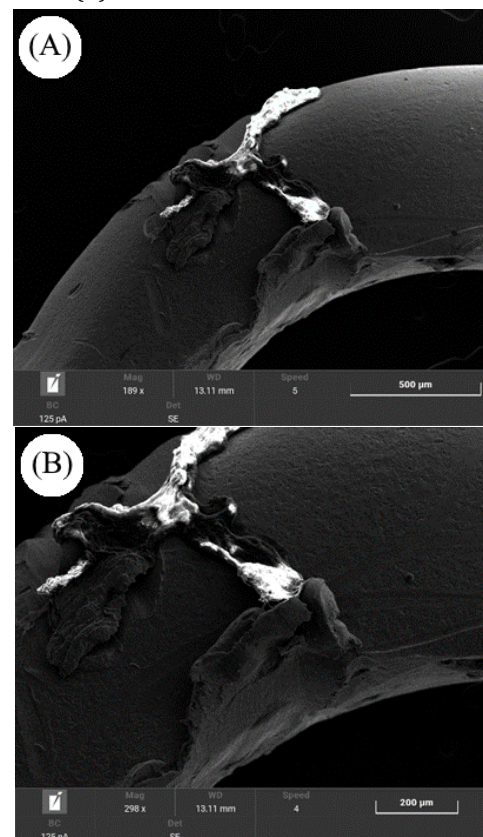
**Figure 10.** Images of the detail located on the stabilization plate

The Hofer INTEOS Mini Fragment, which was shown in its entirety in Fig. 6 (A), and its details shown in Fig. 8 (A), additionally displayed a spot that drew particular attention due to the presence of an unidentified object that was irregular in shape and did not look like a cavity. Its image is shown in Fig. 10. The object is characterized by a different contrast to the rest of the test plate (it contrasts brightly in the SEM image). From the images alone, it is not possible to determine the origin of the material excess. For this reason, in addition to the images showing the test material, an EDS chemical composition analysis was carried out. As a result of the analysis, graphs in the form of histograms of chemical elements detected on the surface of the material were plotted, as included in Fig. 11. The left part of the image (A) presents the results for the test material of the stabilizer plate in the worn state, while the right part of the image (B)

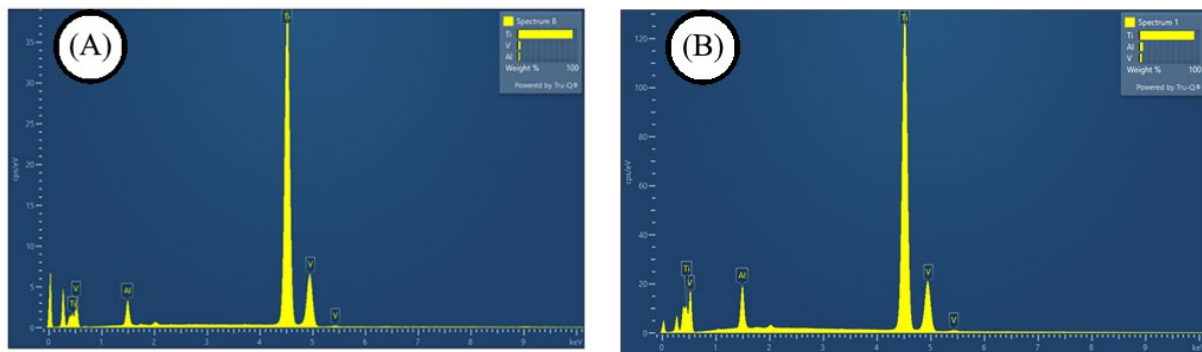
**Figure 11.** Chemical composition analysis in the form of a histogram of the elements of the implant material: used (A), new (B)

On the basis of the plotted histograms of the chemical composition of the test material, tables were prepared containing the percentage content of the elements included in the test alloy. Accordingly, Table 1 shows the percentage content of the chemical composition of the sample – stabilizing plate in the worn state. Table 2 shows the percentage content of the chemical composition of the sample – stabilizing plate in the delivered (unused) state.

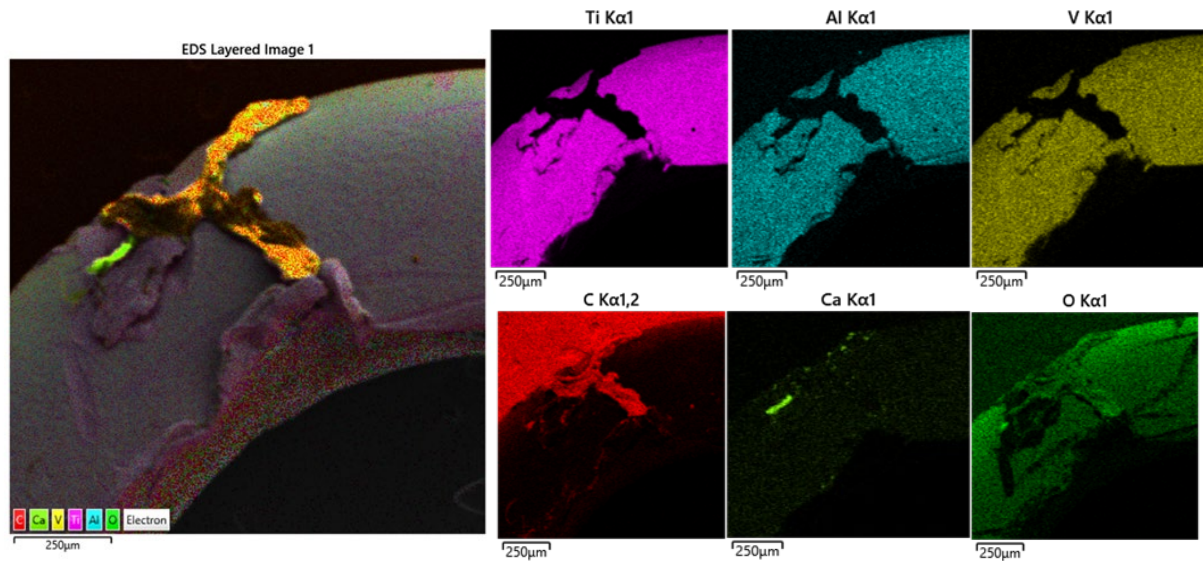
The EDS analysis of the chemical composition was used to investigate the localized foreign body component, the results of which are shown in Figure 12 in the form of spectra located on the outer layer of the material along with the distribution of the elements detected. It is noted that the foreign body in the form of a material excess adjacent to the implant material is not the source material itself (Ti-6Al-4V alloy). The element spectra shown indicate the presence of calcium (Ca), carbon (C) and oxygen (O).

**Figure 12.** The analysis of the chemical composition of the localized detail of the deposited foreign body on the element of the stabilizing plate and the individual spectra of elements

The presence of carbon (C), calcium (Ca), oxygen (O) on the plate taken from the tissue environment may indicate the deposition of a layer of calcite (calcium carbonate) on the surface of the alloy, which may indicate that orthopedic implants can cause various tissue reactions, including mineral deposition. The tissues around the implant may try to "integrate" the foreign material, which can lead to the deposition of minerals, including calcite. However, this process is not dangerous to the tissue environment.
