Aleksander Hebda^{1*}Aleksandra Małeck², Hubert Hebda³, Jakub Zelek⁴¹ Department of Manufacturing Engineering and Materials Science, Opole University of Technology² Faculty of Biology and Environmental Protection, University of Lodz³ Mechanical Faculty, Opole University of Technology⁴ Department of Electric Power Engineering and Renewable Energy, Opole University of Technology*Corresponding author: a.hebda@po.edu.pl

Effect of tissue environment on the structure and properties of Ti-6Al-4V alloy

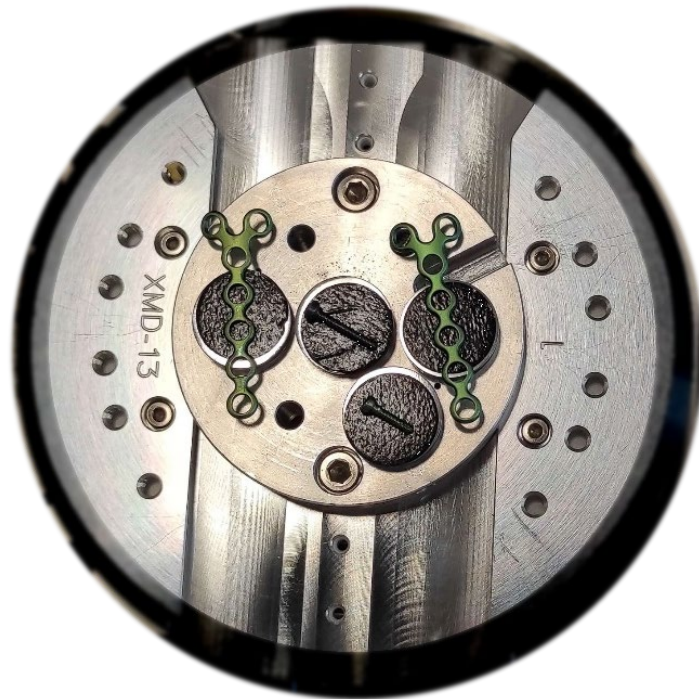
Figure 3. Hofer INTEOS Mini Fragment stabilization plate used for the study

"INTEOS 1.5 Standard screw as av st T 1.5 x 7" (screw), which are shown in Fig. 3. The tested material was a stabilizer for a fractured bone, made of Ti-6Al-4V titanium alloy. In the first case, the implant was in an unused state (left plate and the shorter of the screws in the figure), while in the second case, the implant was in the tissue environment of a 17-year-old patient for a period of 14 months (right plate and the longer of the screws in the Figure).

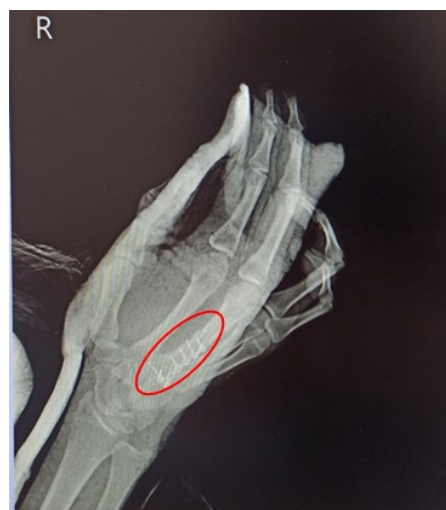
Figure 4. X-ray with the fracture site marked for later treatment

The patient was admitted to the trauma and orthopedic surgery department with a diagnosed spiral fracture of the third metacarpal bone of the right hand, as illustrated in Fig. 4.

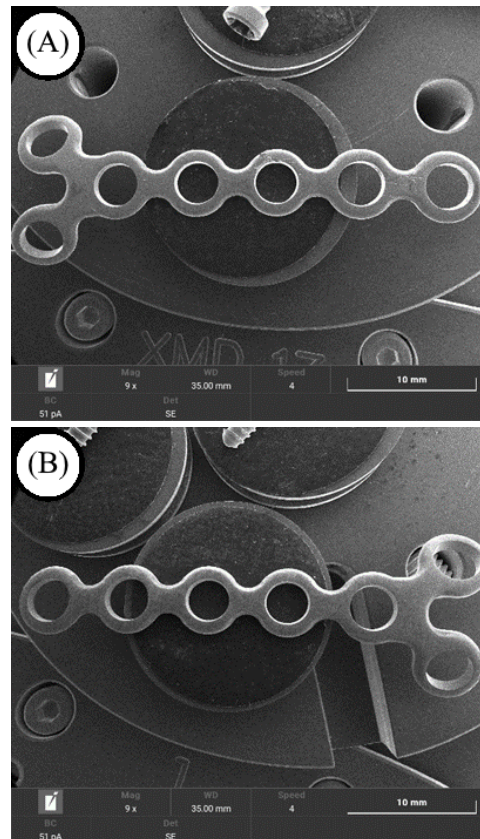
Figure 6. Images of the stabilizer plate: image of the worn plate (A), image of the new, unused plate (B)

For the preset magnifications, no major differences are noticeable, while there are locally different spots when comparing the two versions of the tested implant. These are described in more detail in the following figures (Figures 8, 9, 10), by increasing the magnification, which gave the opportunity to observe local irregularities in the structure of the tested material (this mainly concerns the version of the implant removed from the tissue environment).
