## Effect of tissue environment on the structure and properties of Ti-6Al-4V alloy

This study characterizes the material characteristics of the Hofer stabilizing plate, in the form of a used plate that resided in the tissue environment acting as a stabilizer for the spiral-fractured 3rd metacarpal bone and a new, unused plate.

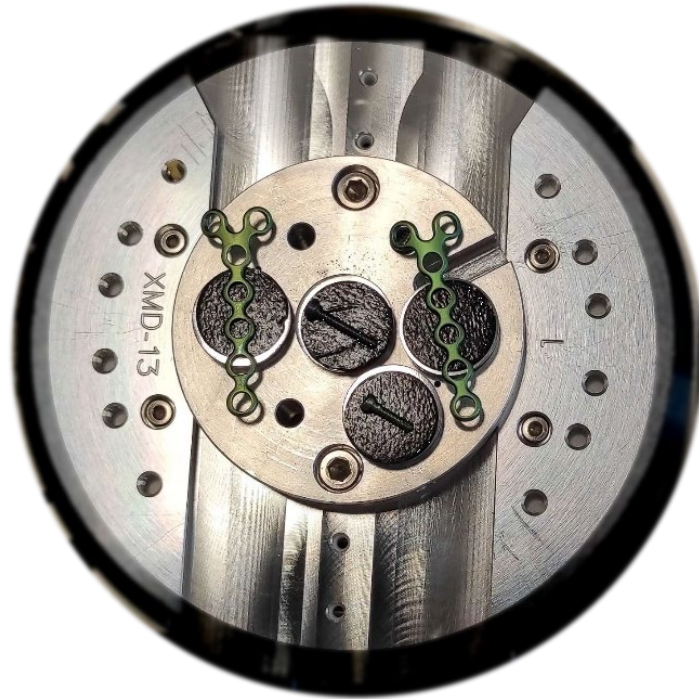
"INTEOS 1.5 Standard screw as av st T 1.5 x 7" (screw), which are shown in Fig. 3. The tested material was a stabilizer for a fractured bone, made of Ti-6Al-4V titanium alloy. In the first case, the implant was in an unused state (left plate and the shorter of the screws in the figure), while in the second case, the implant was in the tissue environment of a 17-year-old patient for a period of 14 months (right plate and the longer of the screws in the Figure).

**Figure 3.** Hofer INTEOS Mini Fragment stabilization plate used for the study

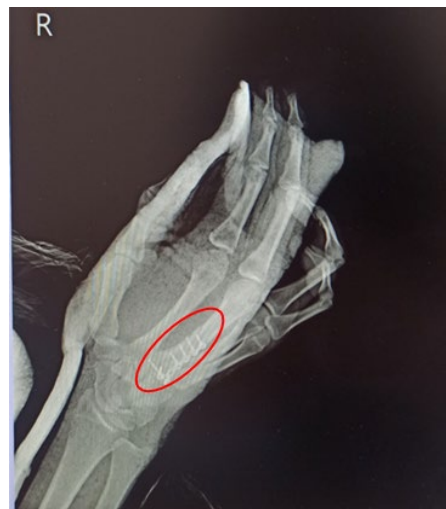
The patient was admitted to the trauma and orthopedic surgery department with a diagnosed spiral fracture of the third metacarpal bone of the right hand, as illustrated in Fig. 4.

**Figure 4.** X-ray with the fracture site marked for later treatment

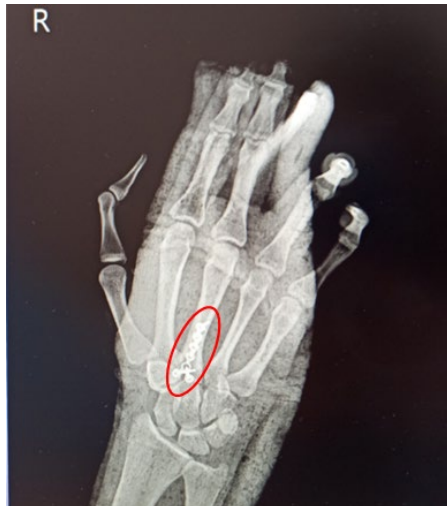
For the fracture, treatment was applied in the form of open repositioning and stabilization of the fracture using the kit mentioned earlier. The plate was inserted in the designated place, as shown in Figure 5. As a follow-up, the patient was given a plaster splint with support for fingers II and III and was discharged home. The issue of plate removal was left to the patient's discretion, after treatment was completed. The optimal time for removing the plate is considered to be between 1–2 years after its insertion. Removal of the material after a longer period of time, can be troublesome due to the possibility of complications when removing such a fine metal. Therefore, the target decision was to remove the bone-stabilizing material after a period of 14 months.

**Figure 5.** X-ray with the Hofer plate fracture stabilization site marked
